A Naval Safety Center Publication

approach

OCTOBER 1970 THE NAVAL AVIATION SAFETY REVIEW

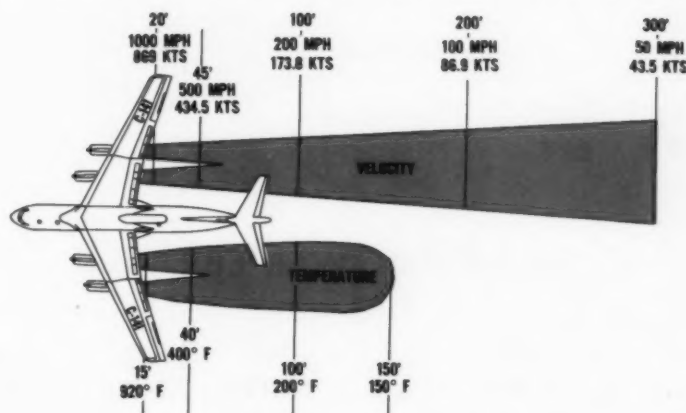
C-141 JET WAKE (Takeoff Power)

A review of C-141 jet exhaust velocity data at takeoff power is presented in Fig. 1 for use as a comparison with C-5A test results. MAC (Military Airlift Command) has

been operating the C-141 for several years on a worldwide basis without any serious exhaust velocity problems, although pilot technique has been an important factor. All temperature and velocity profiles are for four engines running, although the temperature profile is shown on one side of the aircraft and velocity on the other. As shown here, the exhaust velocity would be damaging if high power were to be carelessly applied in congested ramp or terminal areas. Note in Fig. 1 that the C-141 exhaust temperature is 150°F at 150 feet distance; yet, as shown in Fig. 2, the exhaust temperature for the C-5 at takeoff power is less than 100°F at that same distance.

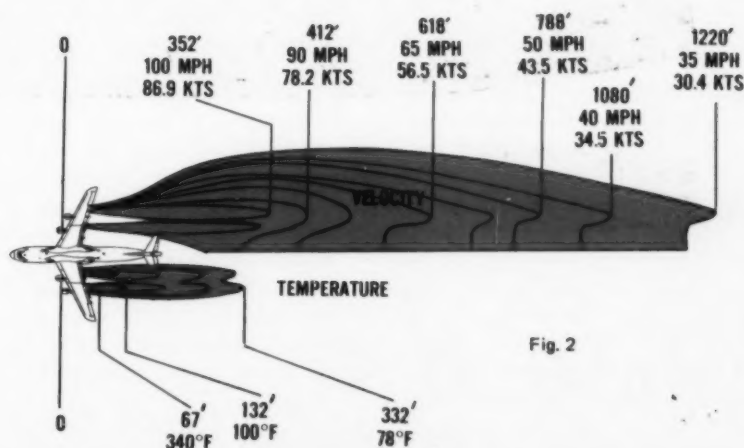
C-5A JET WAKE (Takeoff Power EPR-5.08)

As can be seen in Fig. 2 the exhaust air flow of the C-5 at *takeoff power* forms into two ridges of high velocity air on the extended centerline between the inboard and outboard engines and a trough of lower velocity air along the extended aircraft centerline. The exhaust of the two engines on either side merge at approximately 350 to 400 feet into an exhaust velocity pattern of about 90 mph. This exhaust has such force and volume feeding it that it is slow to decrease in velocity and will not drop to 35 mph until reaching the overrun area of the runway. Therefore, it would appear advisable to condition the overrun the width of the runway for prevention of erosion by the air velocities indicated. Any areas in which the aircraft engines are to be run up for power checks will also require conditioning aft of the aircraft. C-5A engine exhaust temperatures are not a problem and should not induce sufficient heating of the asphalt to cause deterioration of the binder or to reduce adherence of the asphalt wearing surface to the base. Concrete joint material should not be affected.

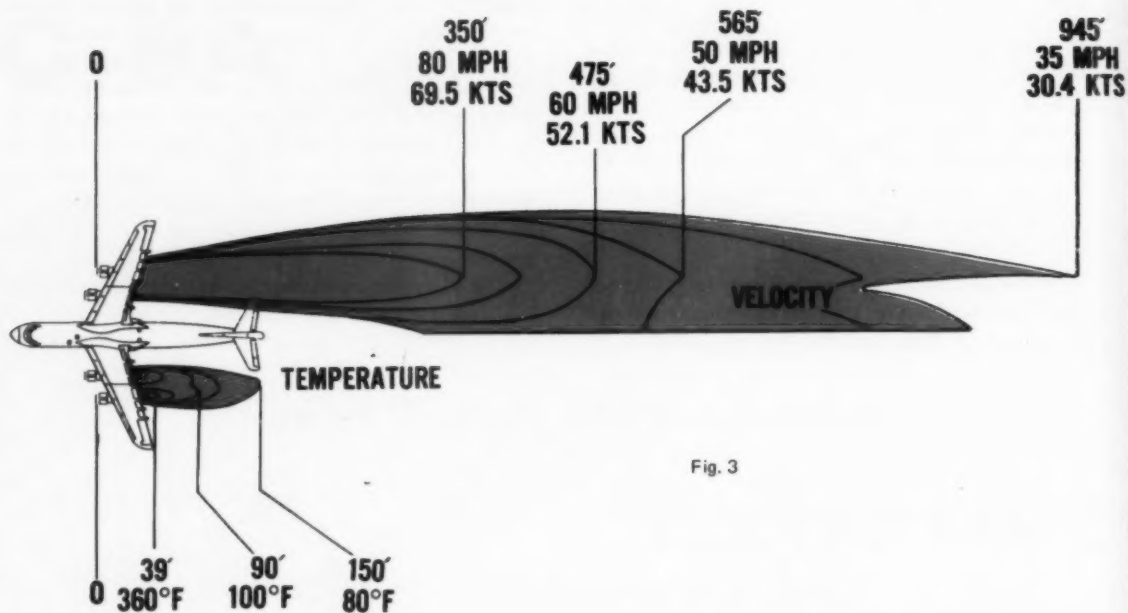
Fig. 3

C-5A BREAKAWAY POWER EPR-3.4

C-5 *breakaway power* (Fig. 3) is probably the most critical power setting in regards to the possibility of injury to personnel and damage to other aircraft and support equipment. For this reason, the maximum power setting (EPR 3.4) which could be anticipated for breakaway under the *most* adverse conditions was selected. The conditions which would require this power setting are considered rare. Experience indicates that normal breakaway can be accomplished at approximately 25 percent thrust (EPR 2.0).

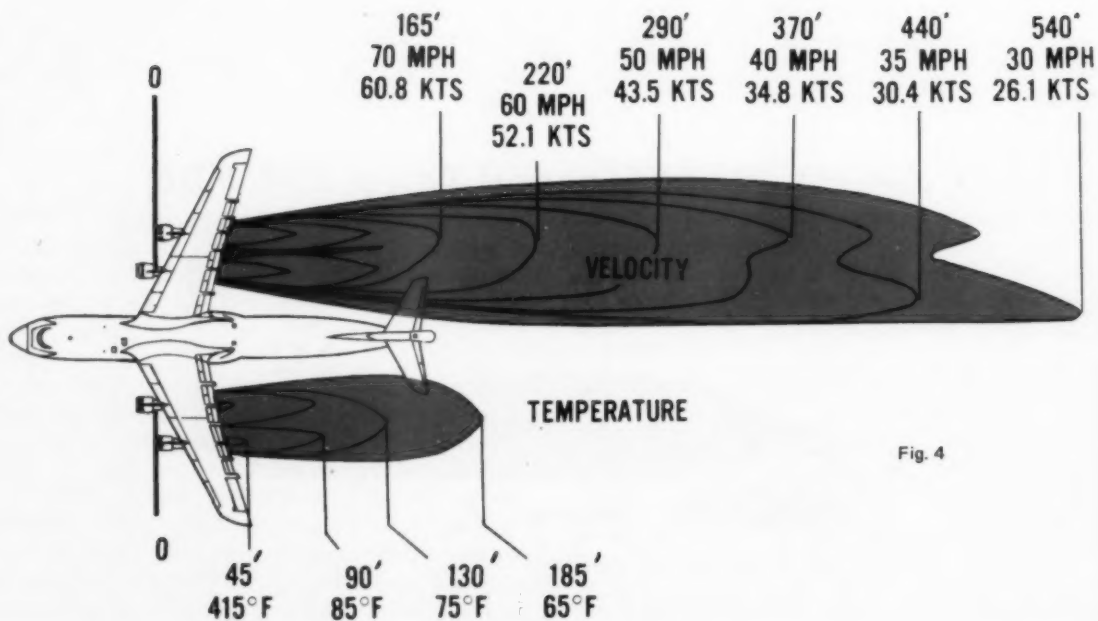
Fig. 4

C-5A TAXI POWER EPR-1.64

Figure 4 shows the exhaust velocity and temperature at *taxi power* setting. Note that the velocity at 165 feet is 70 mph. These velocities decrease in a somewhat irregular pattern until they reach 35 mph between 400 and 440 feet. From the velocities shown and from observations made at Dobbins AFB, it would appear that a good stand of grass is all that is required for normal stabilization along each side of a 75-foot taxiway. Paved shoulders may be required at stations with frequent C-5A operations and poor soil or dry climate.

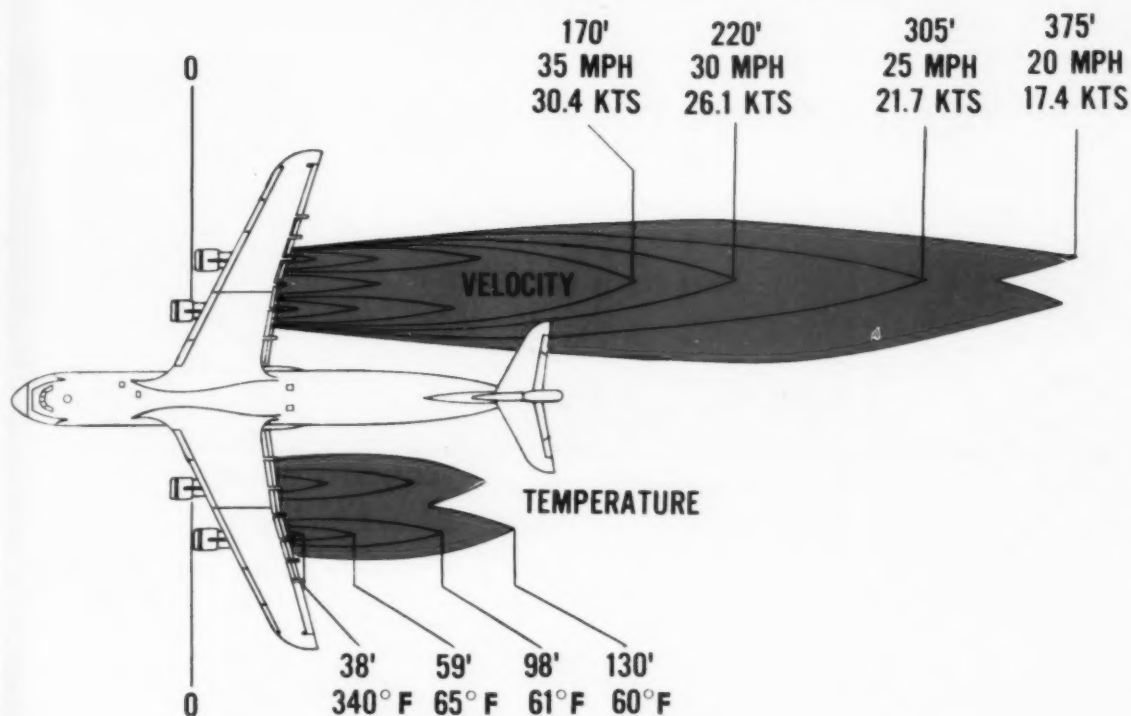
Fig. 5

C-5A IDLE POWER EPR-1.2

Idle power (Fig. 5) exhaust velocity and temperature

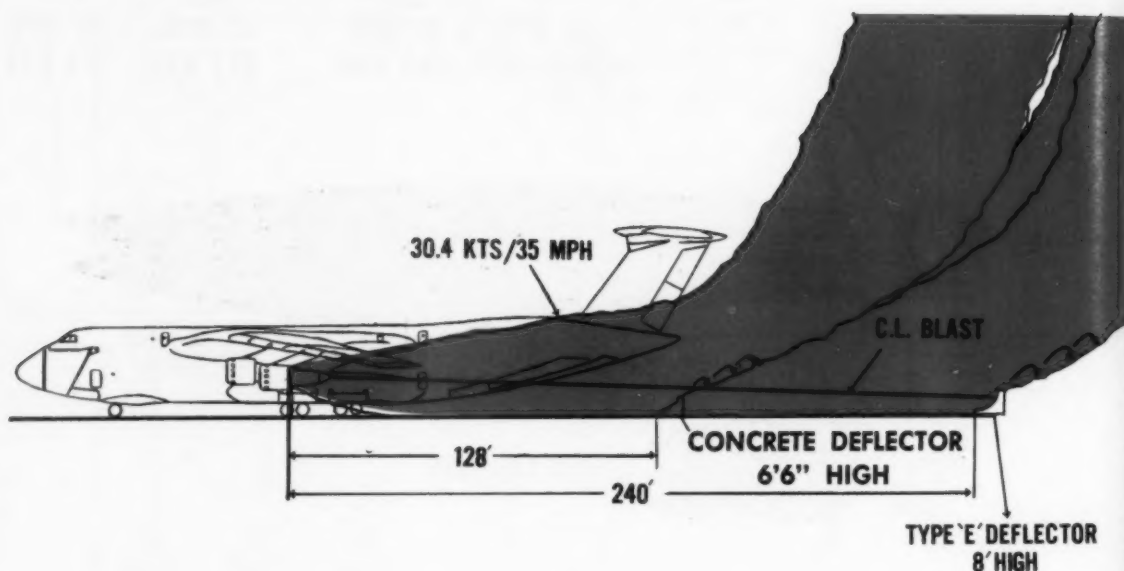
Fig. 6

BLAST DEFLECTION (Idle Power)

Figure 6 (above) displays two different exhaust blast deflector applications. The first shows the blast deflected by a concrete shell with dirt fill six feet six inches high placed immediately below the tailcone of the aircraft. This is the type which is used by Lockheed and has proven to be very successful. With this type deflector the blast appears to be drawn downward to the pavement where it impacts, spreads, then encounters the deflector, which turns the blast upwards with a turbulent motion, which in turn deflects the higher strata of the exhaust upward and causes a rapid deceleration of the air movement. The second type blast deflector is the all metal, type E, shown in AFM 88-2 and is the preferred type for C-5 aircraft. Other types are recommended for dual use parking positions where C-141, C-133, C-124 or C-130 aircraft are also to be parked. This type is located at approximately 250 feet aft of the outboard engine fan nozzle and should be about eight feet high, thus the centerline of the outboard engine exhaust will impinge about one-third of the way down from the top of the deflector. The

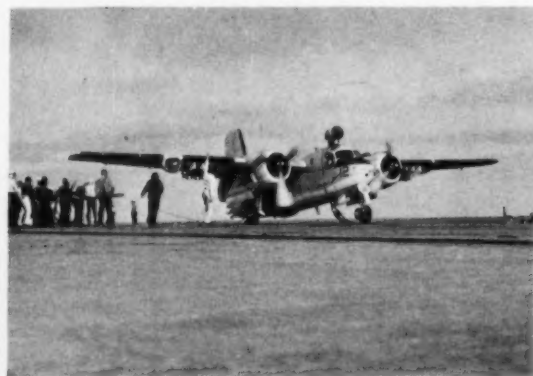
● During an S-2 cat shot the MAD boom extended and struck the deck causing a slight wrinkling of the

boom and damage to the MAD head cover. About an hour prior to the flight the boom had been manually cranked out to change the head. The technician who performed the work couldn't remember removing the crank after he completed the job. None of the crewmembers inspected the aft section of the electronics compartment sufficiently to notice that the crank was still installed in the manual extend/retract MAD boom

socket. The crank was discovered when a crewman went aft to crank the boom in after its inadvertent extension during the cat shot. The aircraft was subsequently diverted to a nearby air station and landed without further incident. The investigation revealed:

- The retract cable was broken at the drum resulting in the inability to manually retract the boom.
- Normal operation of the electrical extend/retract system.

- With the handcrank removed and the mechanical lock visually checked unlocked, it is impossible to apply enough force to the boom to pull it out or push it in by hand.

Although the technician stated that the boom extended and retracted electrically with the handcrank installed, it is doubtful that it did. In his haste to complete the work in time for the next launch it is believed that he *thought* he saw the boom retracting as he came outside the aircraft because that is what he *expected* to see. The cause of this incident was failure of the technician, collateral duty inspector, plane captain,

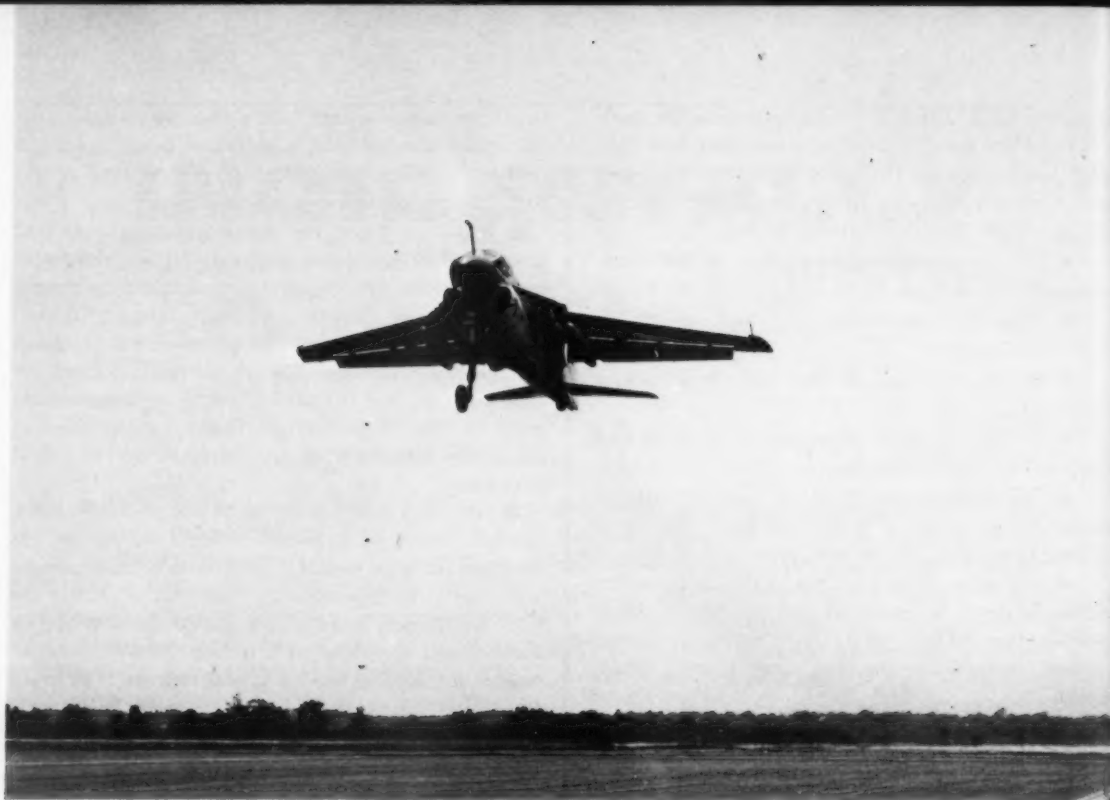
• An A-6A was making an initial 40-degree visual dive for target identification. When a 4G pullout was attempted at 5500 feet AGL, aft control stick movement was limited to approximately one inch of travel. The pilot immediately and abruptly shoved the control stick forward and then brought it fully aft with both hands. Momentary binding was noted and then the stick broke free. The aircraft entered an accelerated buffet until stick pressure was relaxed. Pullout was completed at 2000 feet AGL. A climb was made to 17,000 feet MSL at 90 percent rpm and the aircraft was slowed to 225 kias for a control check. Gentle stick movement aft was possible with no binding noted. The pilot then put the aircraft into a 90-degree bank, simultaneously added 100 percent power and pulled the control stick fully aft. A flameout occurred as the starboard engine accelerated to 100 percent. The pilot leveled the wings and accomplished a normal relight. An emergency was declared and the aircraft made an uneventful landing at a naval air facility. Postflight inspections revealed that an Adel clamp had been lodged in the control crank assembly area beneath and aft of the pilot's seat. A clamp of this type is not normally used in this area, however, an Adel clamp was missing from electrical wiring aft of the pilot's seat. The Board suspected that this clamp had worked loose and gained entry into the control crank assembly. Also found in this area was a standard Navy flashlight lens and a piece of curled plastic one-half inch by three inches. These were discounted as the culprits of the control jamming. It was suspected that the flameout occurred due to engine acceleration demands coupled with rapidly increasing angle of attack. No engine discrepancies were noted during postflight inspection. This type incident could very well have resulted in the loss of an aircraft and crew. Improperly securing clamps has led to disasters in the past. The fact that other debris was found in the area of the control crank assembly emphasizes the need for thorough inspections of aircraft to ensure that they are

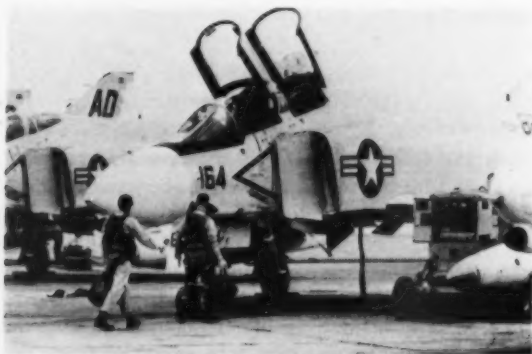
• A technician was assigned to install a new rear seatpan in an F-4J. After removing the rear seatpan and lumbar backrest, he left the backrest lying between the starboard intake and fuselage. As the aircraft was being preflighted, a different technician was ordered to complete the installation. He carried a rear seatpan and backrest to the F-4 and installed them without noticing the backrest which had been removed. During preflight the pilot saw the backrest but he was not concerned because he had been told that someone might be still working on the rear seat. The RIO was distracted and did not see the loose backrest. When the inflight

retracting probe was cycled during pretaxi checks, the backrest was caught in the probe door. Taxi and engine runups were normal. As the aircraft became airborne the exposed portion of the backrest began to flap violently in the wind. Two straps with metal rings attached hit upon the rear canopy with sufficient force to cause several pieces of plexiglass to be chipped from the inside. The pilot immediately returned to the field and made a routine landing. The primary cause of this incident was aircrew error in that the presence of the backrest on an external section of the aircraft should have been challenged by both the pilot and RIO. A contributing cause was maintenance supervisory error in that neither the removal of the seatpan nor subsequent installation received a proper quality assurance inspection. As the C.O. stated in one part of his endorsement, "It has been reemphasized to all aircrews that the final responsibility for the safe operation of an aircraft lies with them. Aircrews are briefed to accept no situation concerning an aircraft about which they are not fully informed."

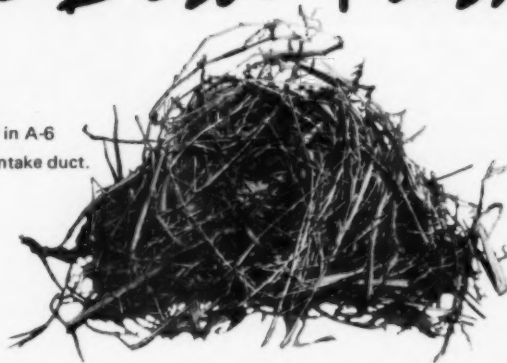
Bird's nest found in A-6
air conditioning intake duct.

THESE photos illustrate what can happen when an aircraft is stored for more than a few days at a time between flights. This A-6 was stored outdoors from 12 May to 8 July and then brought in for a calendar inspection. During the storage period, an enterprising bird with maternal instincts investigated this metal structure, became convinced it had distinct possibilities as a good place to raise a family and so had commenced to set up housekeeping. Unfortunately, from the bird's point of view or fortunately from the maintenance point of view, the aircraft was towed into the hangar, opened up and the nest discovered prior to the egg-laying stage.

If this aircraft had been turned up prior to the discovery of the nest against the air conditioning system's heat exchanger (it was well hidden and would have been extremely hard to see during a preflight inspection), many kinds of things could have happened — not a one of them pleasant or desired.

These photos emphasize the need to *always* conduct a thorough inspection of any aircraft prior to flight — it's the only way to go. ◀

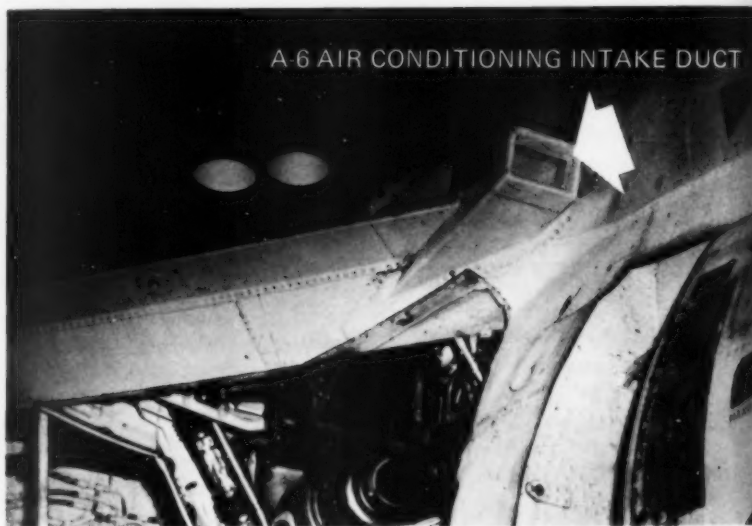
Arrow indicates location of nest found against heat exchanger.

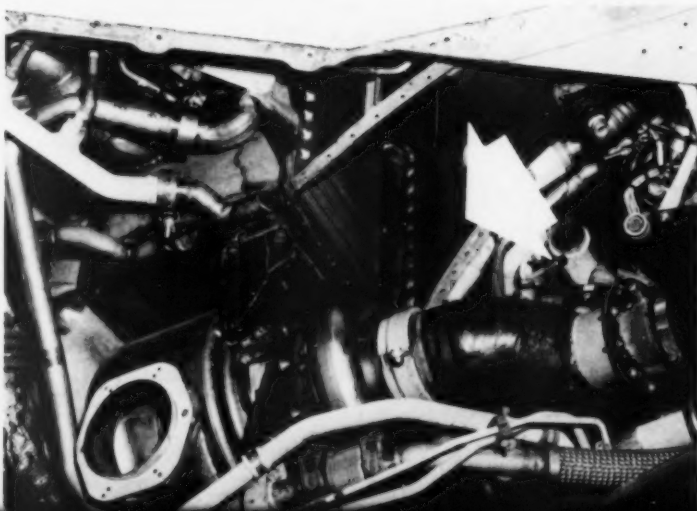
A-6 AIR CONDITIONING INTAKE DUCT
